ZX Spectrum Issue 1 and early Issue 2: Spider / Dead Cockroach timing fix for ULA 5C102

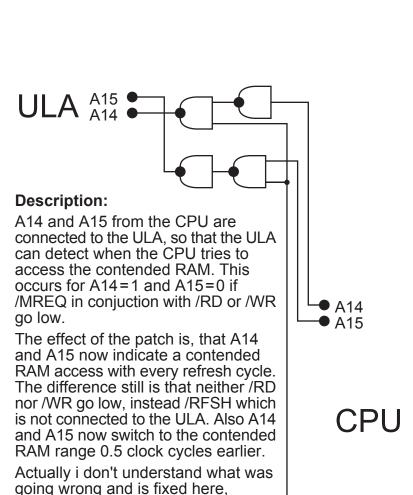
Note: the 47LS00 is shown as

mounted: upside down!
